# CONTRACT AGREEMENT

# CONDITION ASSESSMENT AND REHABILITATION PROPOSAL

Nagarjun Learning Center, Saldum Branch  
Dhading, Nepal

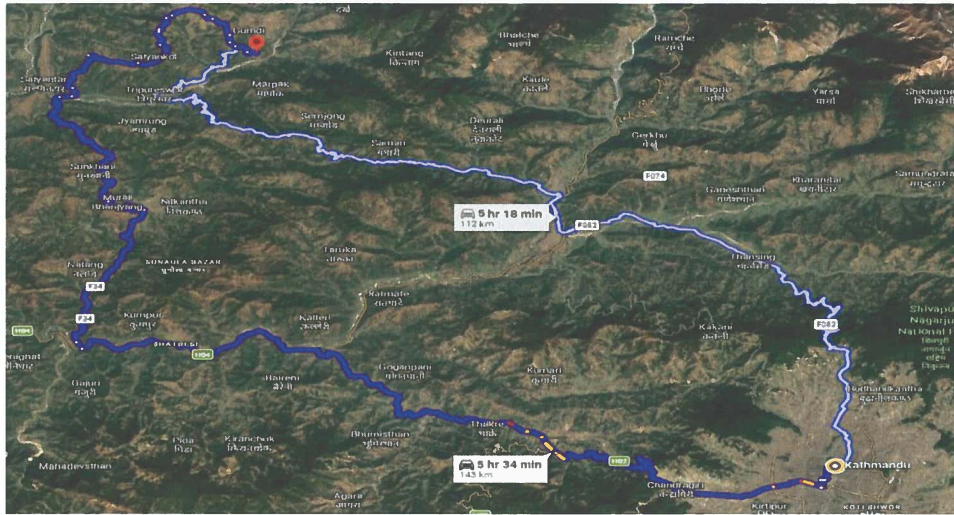
Nagarjun Learning Center is located in Saldum village, Ganga Jamuna-4, Dhading District, at an approximate total travel distance of about 110–120 km from Kathmandu (depending on the selected route). Access to the site involves a combination of blacktopped road, gravel road, and off-road rural track, which has direct implications for construction logistics and scheduling.

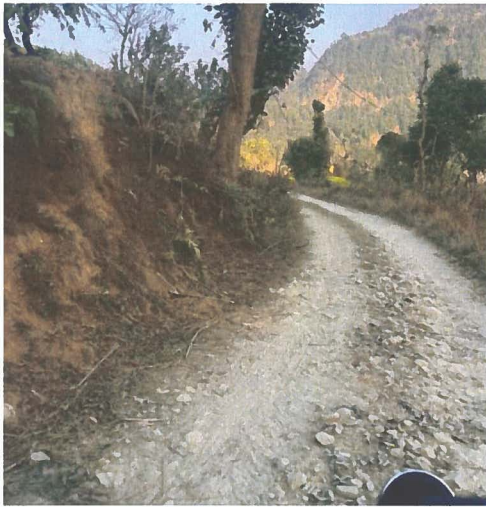
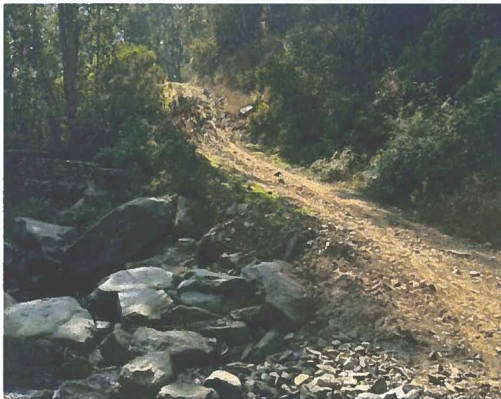
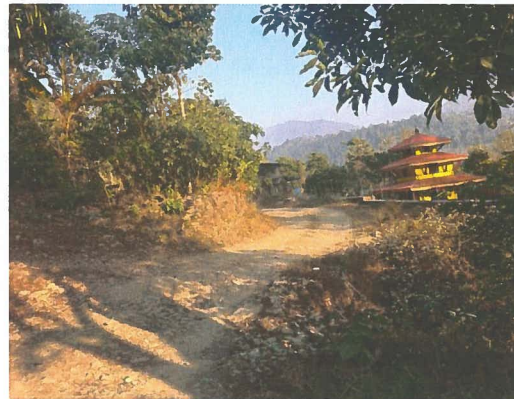
- From Ankhu Khola Bridge to the Learning Center, the route comprises approximately **15.3 km of off-road / rural track**.
- This section is suitable primarily for **four-wheel-drive vehicles** and light construction transport.
- Accessibility is **highly weather-dependent**, with potential difficulties during rainfall due to muddy surfaces, slope instability, and localized obstructions.

Some of the section of the road is significantly deteriorated and will have significant impact on the transportation of the construction material.

The site accessibility has direct implications on material transportation, labor mobilization, and construction scheduling, and has therefore been considered in the proposed cost and implementation timeline.

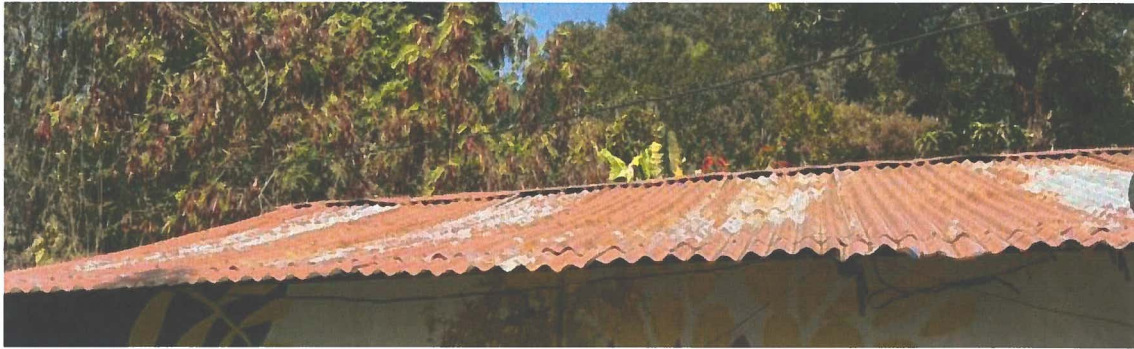
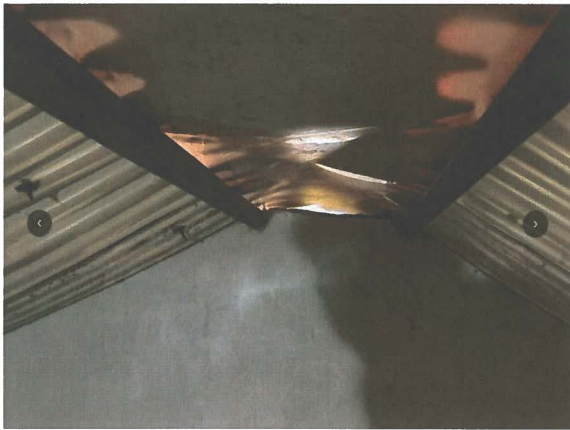
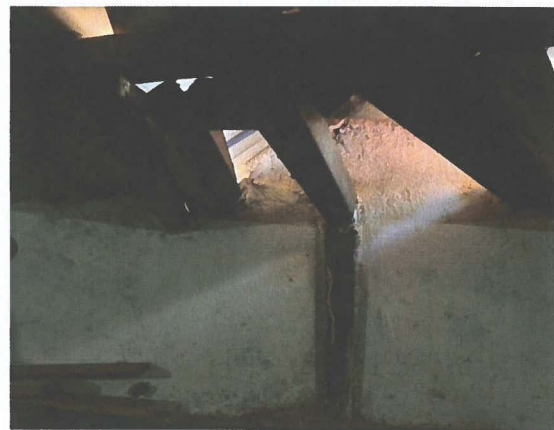
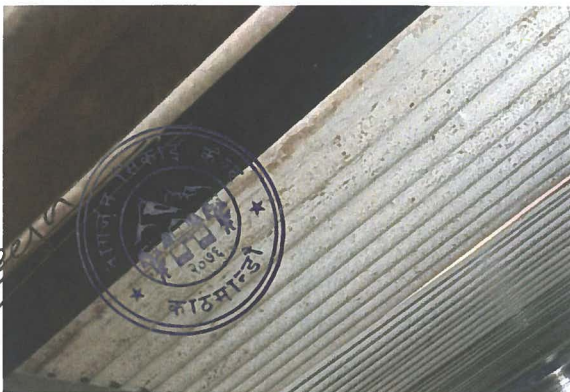
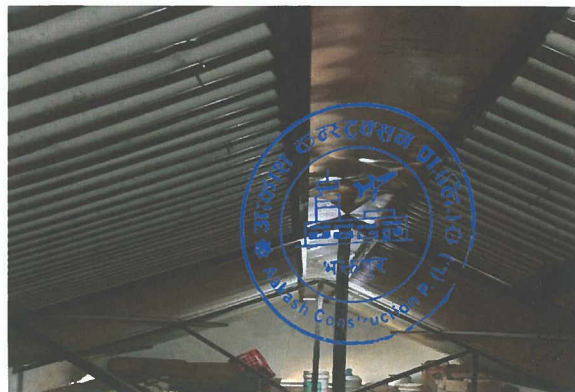
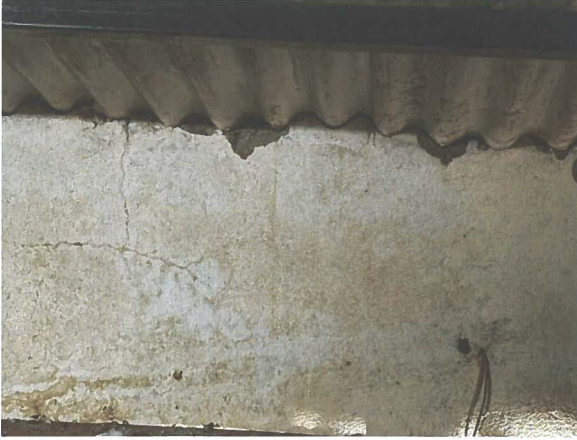
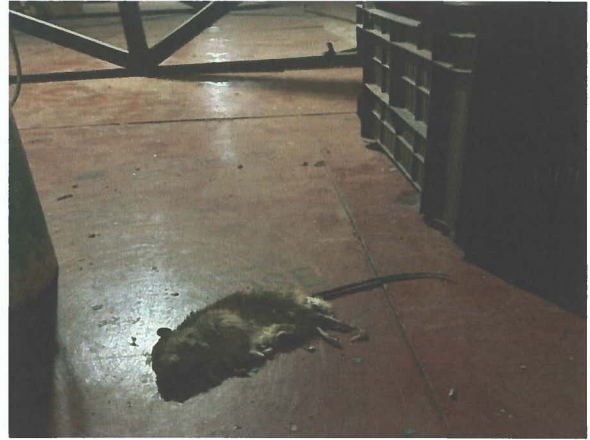
### 5.1 Roof System – Leakage and Thermal Performance

- CGI roof sheets show rusting and corrosion at multiple locations
- Leakage observed during and after rainfall
- Corrosion evident around fasteners and overlaps
- Absence of thermal insulation beneath CGI sheets
- Water leakage observed despite the presence of waterproof plywood
- No gutter or organized roof drainage system has been provided along the roof edges of either the main building block or the kitchen block.

- The existing CGI roof sheets will be replaced with **Puff roof Panel** to address corrosion, leakage, and long-term durability issues.
- All roofing sheets will be installed with properly sealed fasteners and overlaps in accordance with manufacturer specifications to prevent future water ingress.
- A complete gutter and downpipe system will be installed along the roof edges of both the main building block and the kitchen block to ensure controlled roof drainage.
- The gutter system will be connected either to a rainwater harvesting arrangement or to a designated safe discharge point, reducing surface runoff and improving overall water management around the building.
- Sealant to roof and masonry joints.

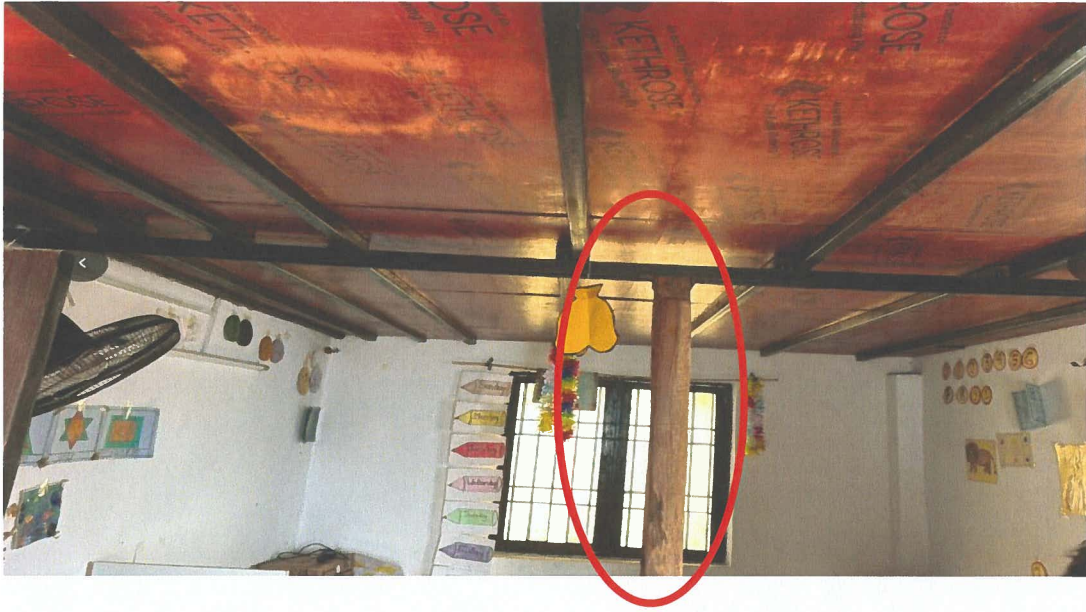
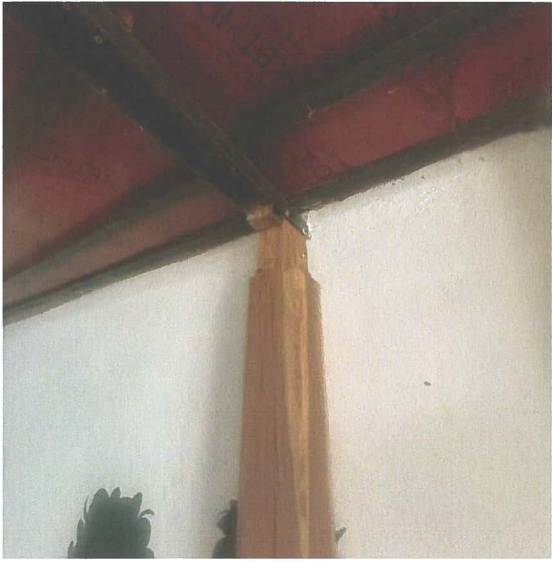
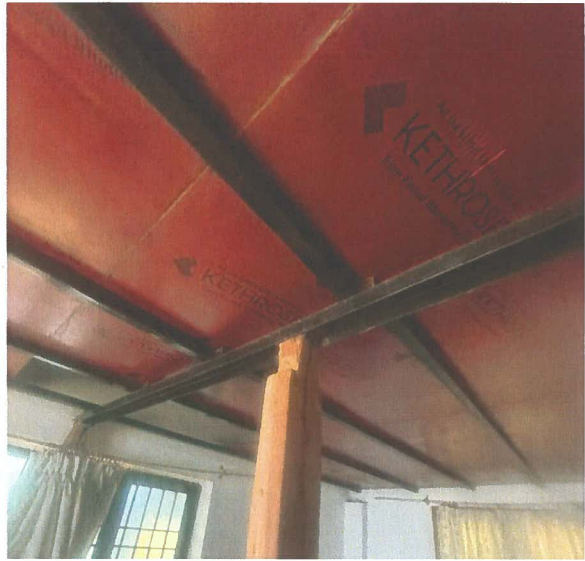
**5.2 Structural Condition – Sagging of Beam/Truss Members**

- Visible sagging/deflection observed in certain roof-supporting beam or truss members
- Minor cracking observed near beam–wall junctions
- Trusses are directly seated on masonry walls without visible bearing pads

**Causes:**

Insufficient structural member size.

- **Square steel pipe columns will be installed at the corners and middle of the building edges to support roof loads.**
- **The existing C-channel beams will be replaced with steel I-section beams, which will be placed on the square steel pipe columns.**
- **Bearing plates and proper connections will be provided to ensure safe load transfer and prevent stress on masonry walls.**

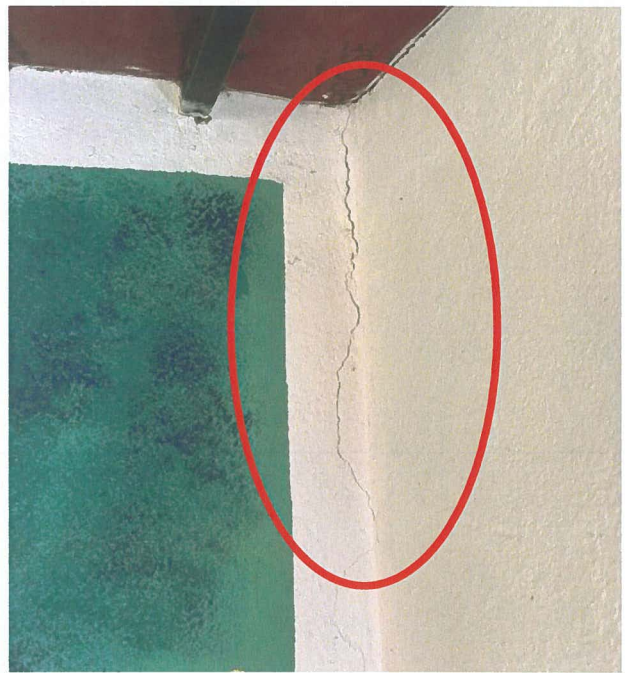
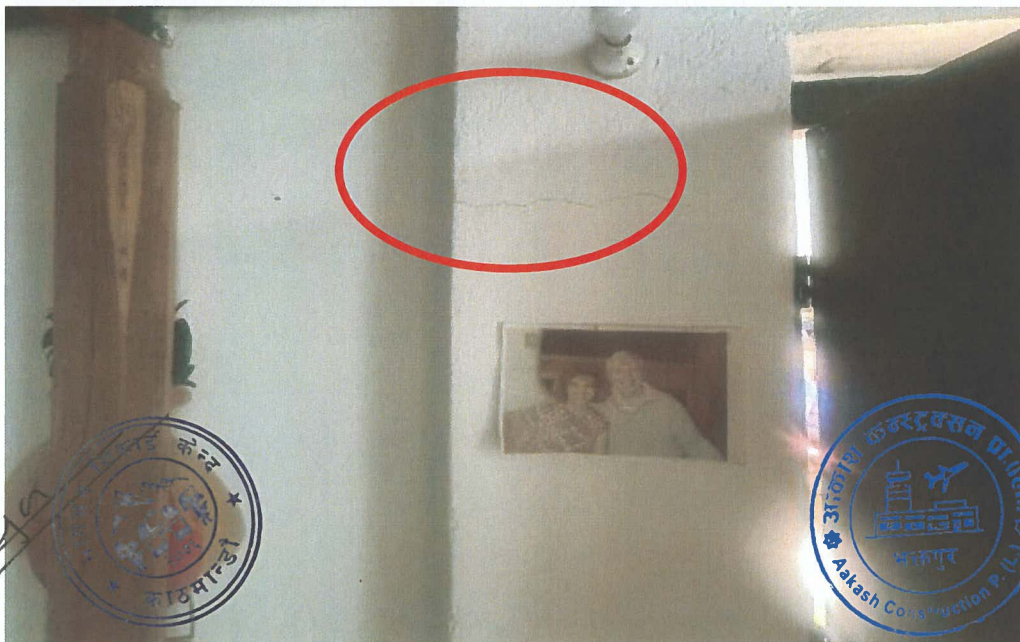
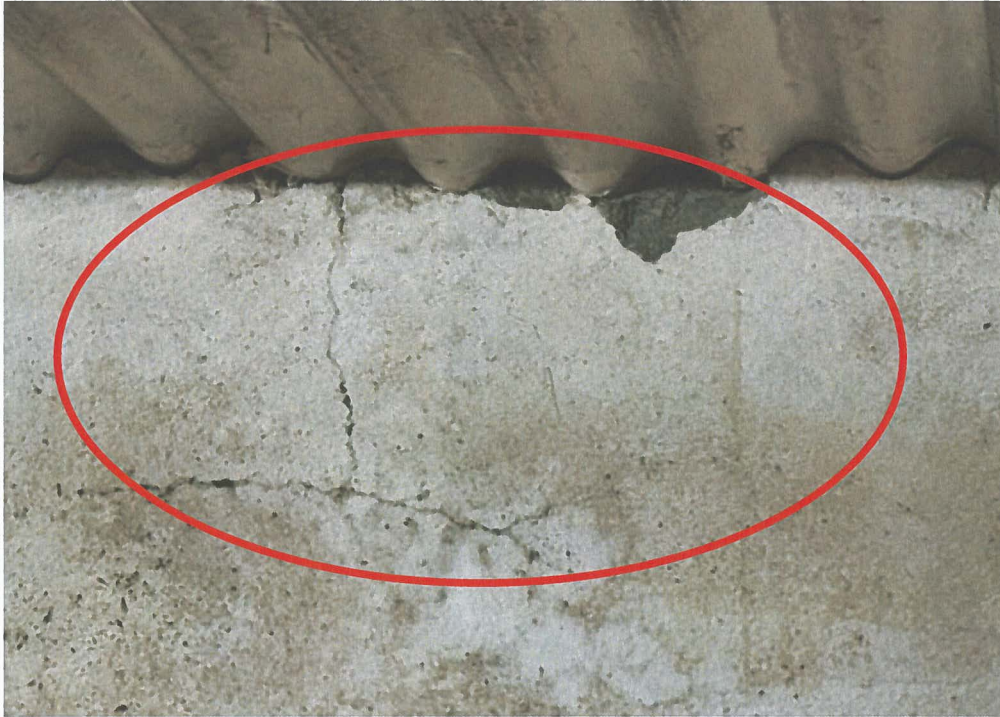
#### 5.3 Walls and Cracks

- Cracks observed in wall plaster at various locations
- Cracks are mostly vertical or diagonal and limited to plaster surfaces

- No visible displacement or separation of masonry units

Based on visual inspection, the cracks appear to be **non-structural in nature** and mainly associated with moisture ingress, thermal effects, and aging of finishes.

- Repair of plaster cracks will be carried out using suitable patching and finishing materials.
- A protective sealant or primer coat will be applied after repair to enhance durability and prevent recurrence.

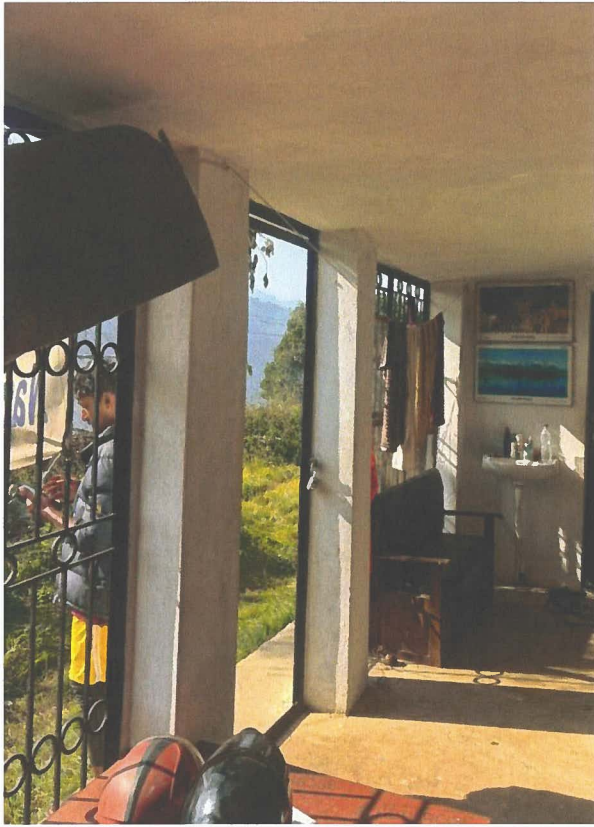
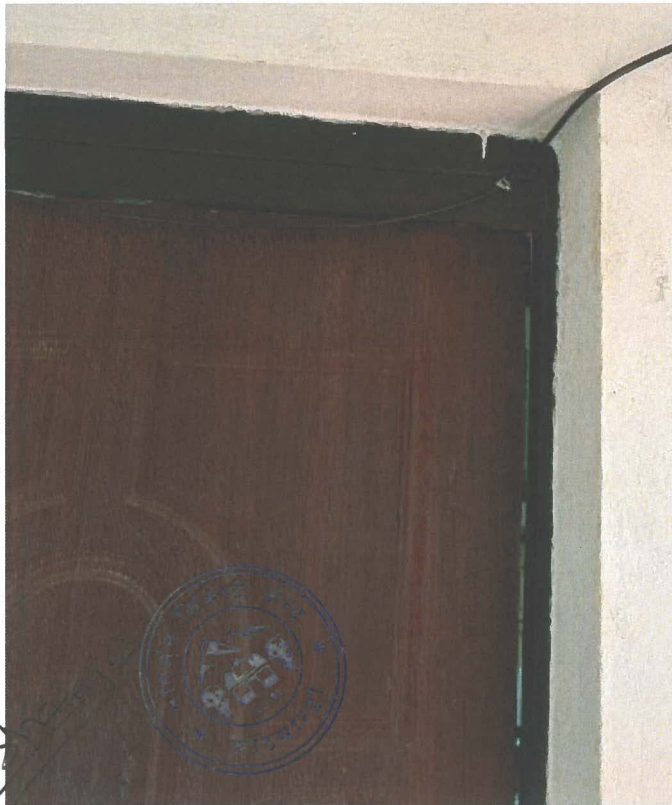
#### 5.4 Doors and Windows

- The main entrance gate to the building consists of an iron grill system without fine mesh or physical barriers, allowing entry of pests, rodents, and small wildlife (e.g., rats and snakes).

- Door and window frames are locally fabricated iron frames, resulting in dimensional inaccuracies and misalignment between frames and shutters.
- Visible gaps are present at frame–masonry interfaces and around shutters due to fabrication tolerances, corrosion, and inadequate sealing.

- While iron grill doors provide a basic level of **security and visibility**, the absence of pest-proof detailing (mesh, seals, thresholds) compromises **hygiene and building integrity**.

- Frame misfits reduce operational performance, accelerate corrosion, and increase vulnerability to **air, water, and pest ingress**.
- The existing condition facilitates entry of insects, rodents, and small wildlife, posing health and safety risks to occupants.

- Gaps and misalignments contribute to moisture ingress during rainfall and reduce the overall durability of doors and windows.

- **An aluminum door will be installed at the main entrance** over the existing iron grill to enhance sound proofing, security, durability, and pest-proofing. This intervention will provide a uniform, durable, and hygienic enclosure, improve thermal performance, and allow adequate clearance for ventilation and exhaust installations, while maintaining existing pest control measures.
- **Metal brackets or plain steel strips will be installed** at locally welded iron frame–masonry junctions or hinge points to align the doors and shutters properly.
- **Interior doors and windows with locally fabricated iron frames and wooden shutters** will be replaced by aluminum doors.
- **Aluminum sliding mesh frames will be installed on all windows**, allowing full operation of the windows while providing **durable pest-proofing**.

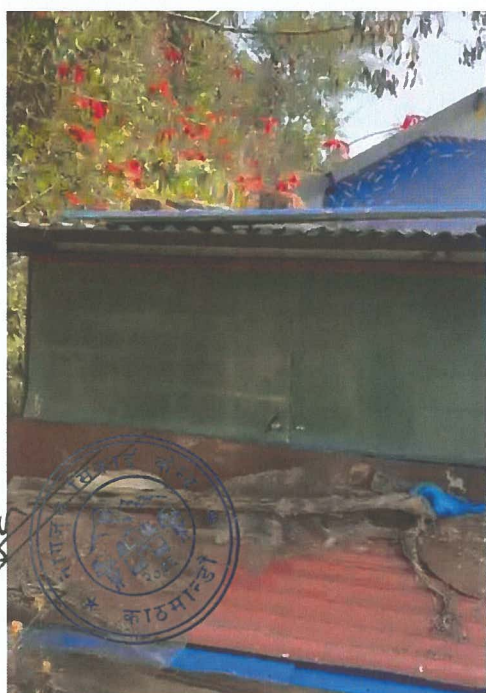
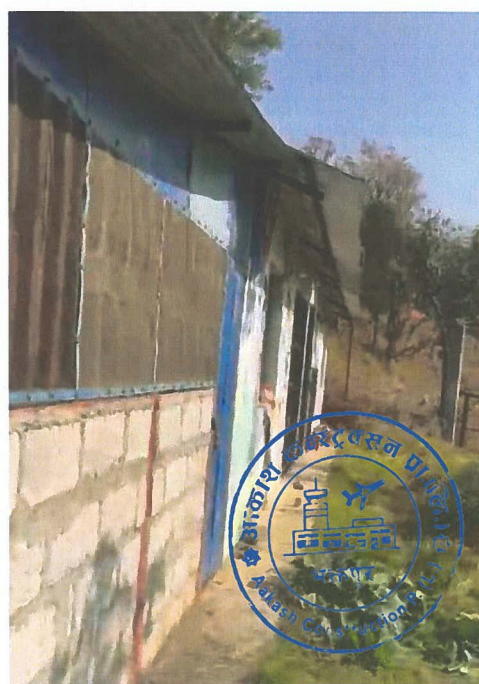
### 5.5 Kitchen Area – Functional and Hygiene Issues

- The kitchen facility is partially enclosed. In approximately half of the kitchen area, the lower portion of the external walls is constructed using hollow concrete blocks up to about 1.6 m height.
- The remaining portion of the kitchen enclosure is formed using galvanized iron (GI) sheets and waterproof plywood, with internal partitioning also carried out using waterproof plywood.
- Iron grill panels with properly installed pest mesh are provided, and no visible gaps were observed in the grill sections.
- The kitchen roof is constructed using corrugated galvanized iron (CGI) sheets, without thermal insulation.
- The overall internal height of the kitchen is lower than that of the main masonry blocks of the building.

- It is recommended to construct the remaining kitchen enclosure fully using hollow concrete block masonry and to raise the overall kitchen height to match the main building block level.
- Aluminum Windows with mesh will be provided to ensure uniform, durable, and hygienic enclosure, improve thermal performance, and allow adequate clearance for ventilation and exhaust.
- The roof of kitchen to be replaced with puff roof panel as for the main building.

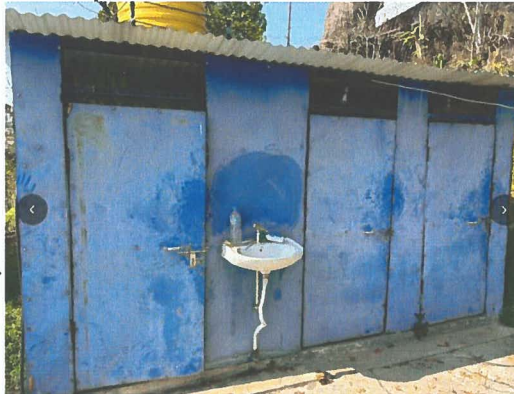
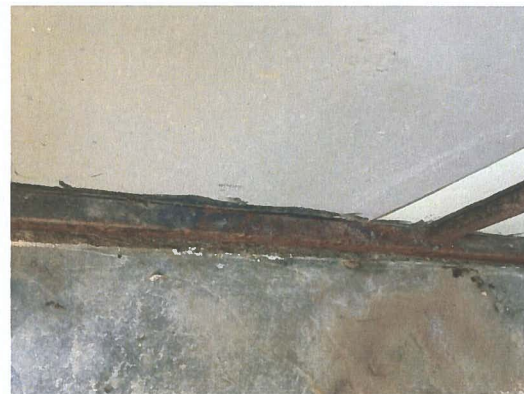
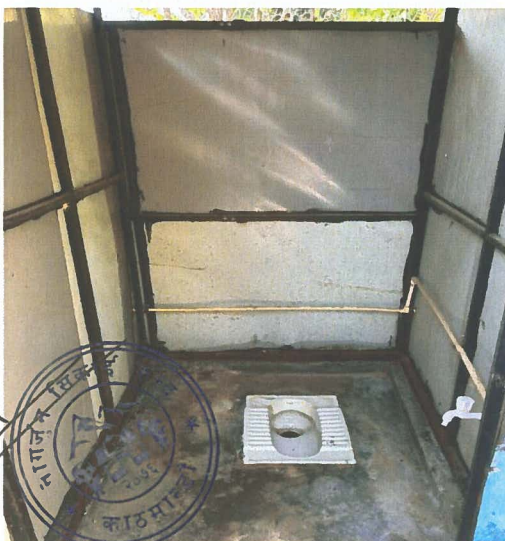
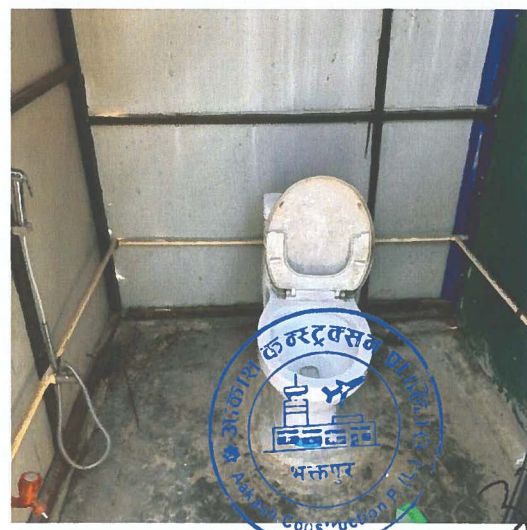
**5.6 Toilet Area**

- The toilet area consists of three partitions: 2 toilets and 1 bathroom.
- One toilet uses a commode system (cover broken) and the other uses a pan system.
- Partitions are currently made of GI sheets with steel pipe frames, which are rusting at the base, reducing durability and hygiene.
- Roof is provided with CGI sheets.

- Walls will be rebuilt using concrete blocks for improved durability, hygiene, and structural stability.
- Steel pipe frames will be removed or replaced where necessary, and the new partitions will be properly anchored to the floor.
- Existing CGI sheets will be provided as roofing over the concrete block partitions to maintain lightweight coverage and waterproofing.
- Commode cover will be replaced.

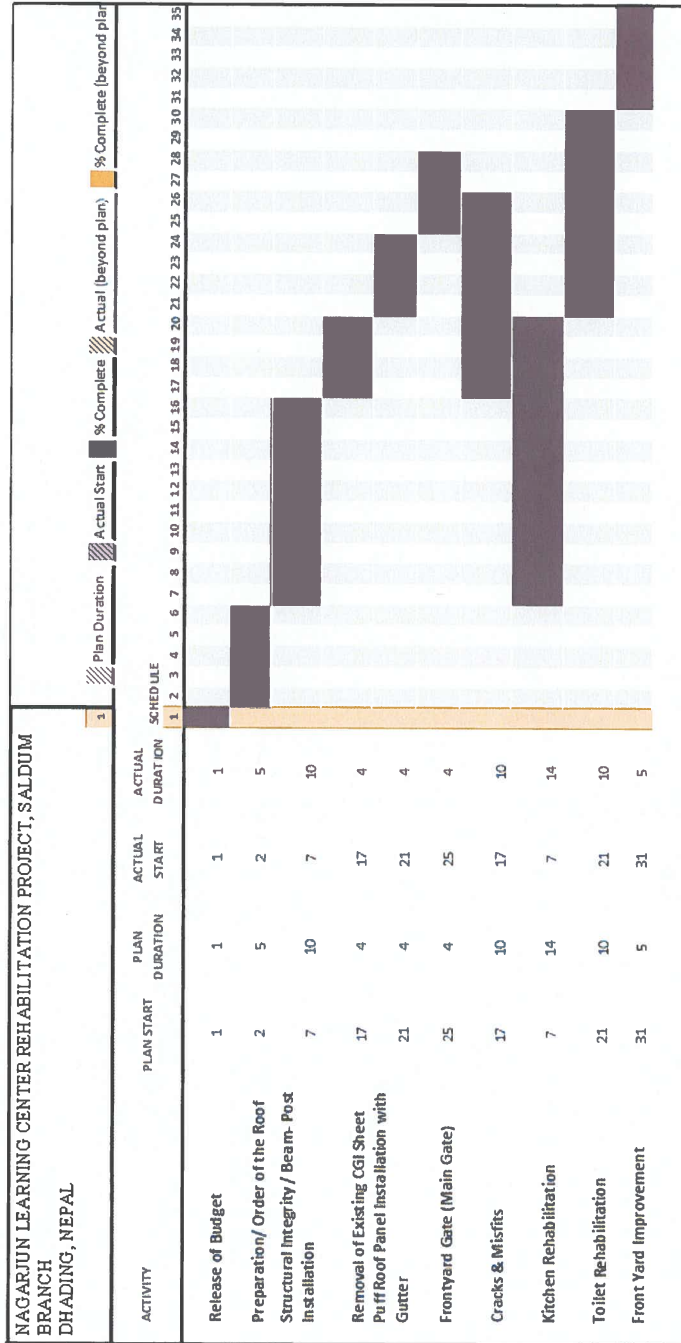
## 8. IMPLEMENTATION SCHEDULE

The proposed rehabilitation works can be completed within a short time frame to minimize disruption to learning activities.

*Schedule may be adjusted based on weather conditions and site access.*
